Manhole Inspection Summary

Manhole # S17QQ1021MH

Insp Date: **6/27/07 9:40 AM**

Location Address: **YELLOWWOOD AVE**

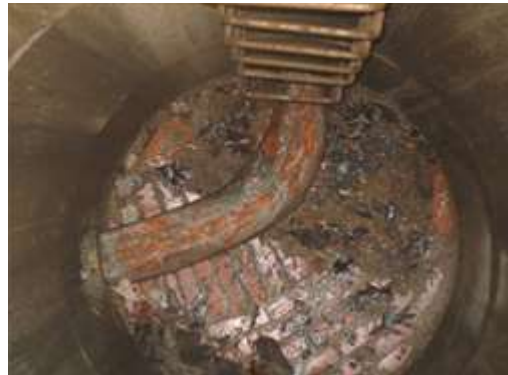
Top View

Evidence of surcharge - Bench debris.

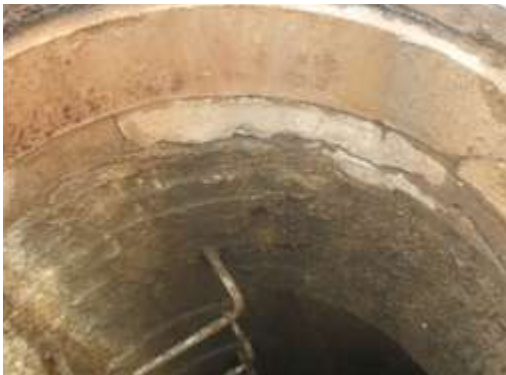
Defect

Frame leaks. Ajustment deterioration and infiltration.

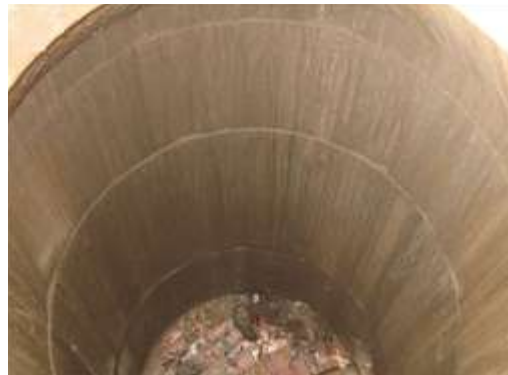
Defect

Corbel infiltration.

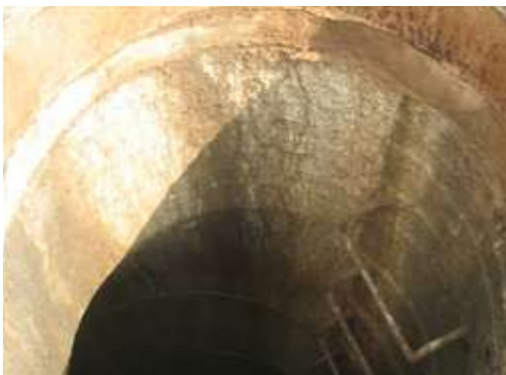
Defect

Adjustment infiltration.

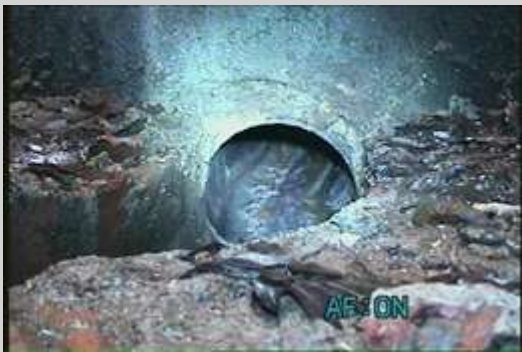
8 in. Circular Gravity Sewer Pipe Out @ 12 O'Clock

Infiltration: **None** Pipe Seal Cond: **Cracked**
